WORK PLAN

- FOR WATERSHED PROTECTION
AND FLOOD PREVENTION

WILLIAMS CREEK WATERSHED

BLANCO, GILLESPIE, AND KENDALL COUNTIES, TEXAS

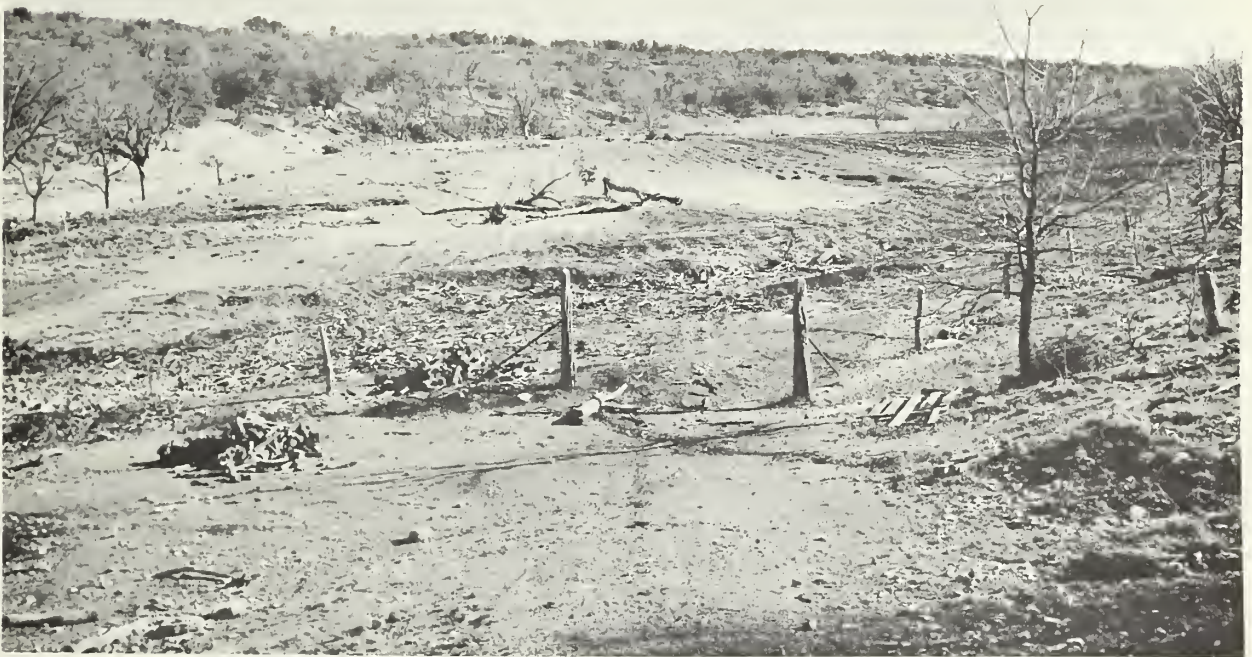
**Floods of high velocity and short duration
cause severe losses in flood plain fields.**

The most recent destructive floods occurred on Williams Creek in 1949, 1952, and 1959. The flood of October 4, 1959, resulting from a rainfall which averaged 10.1 inches over the watershed, inundated 1,000 acres and caused damages estimated at \$30,500. Extensive erosion damage occurred on many acres of freshly tilled topsoil, and infertile sediment was deposited on much of the mainstem flood plain.

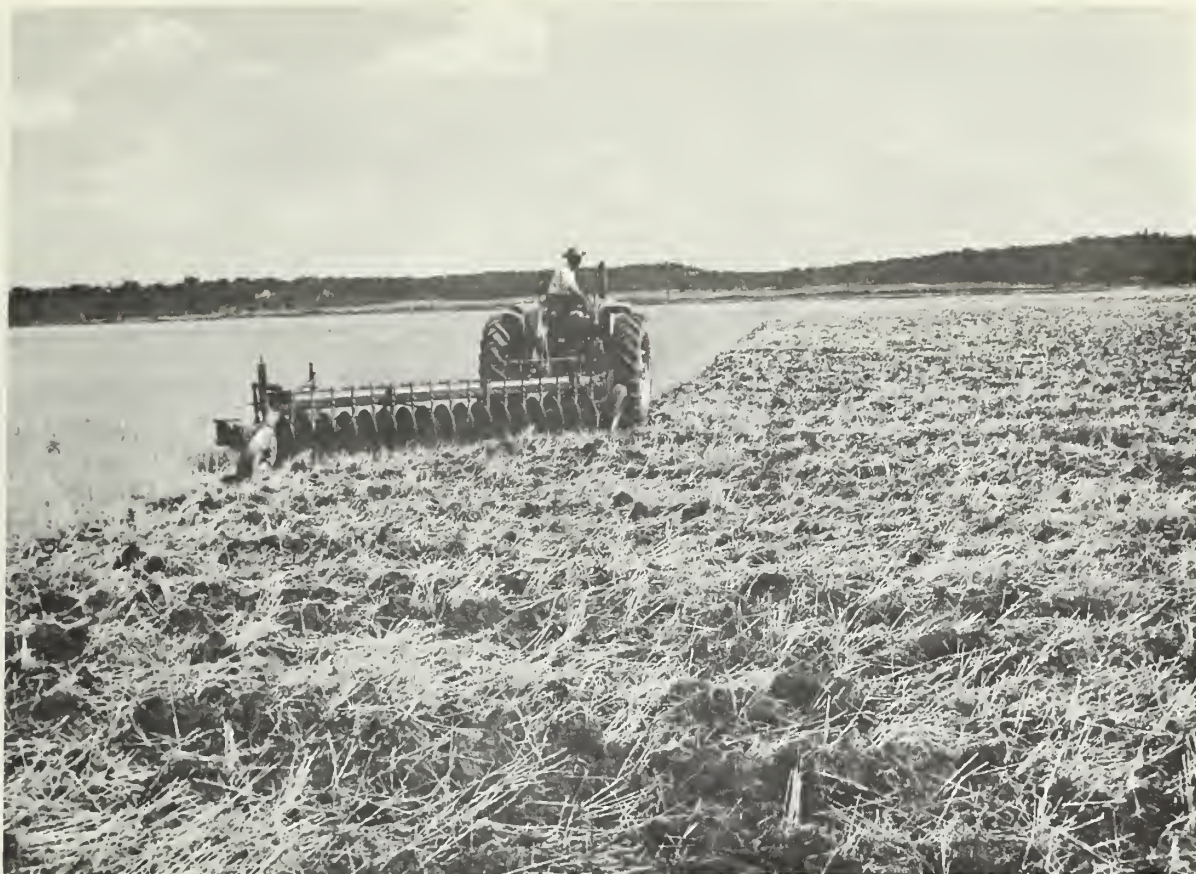
Residue after combining of small grains are left in field for conditioning and protection of soil.

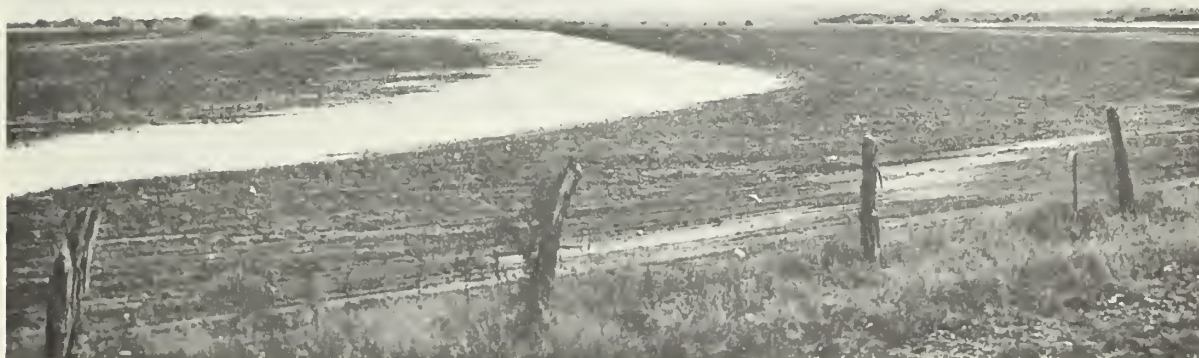
Channel-type terraces are used to control potential floodwaters and protect land.

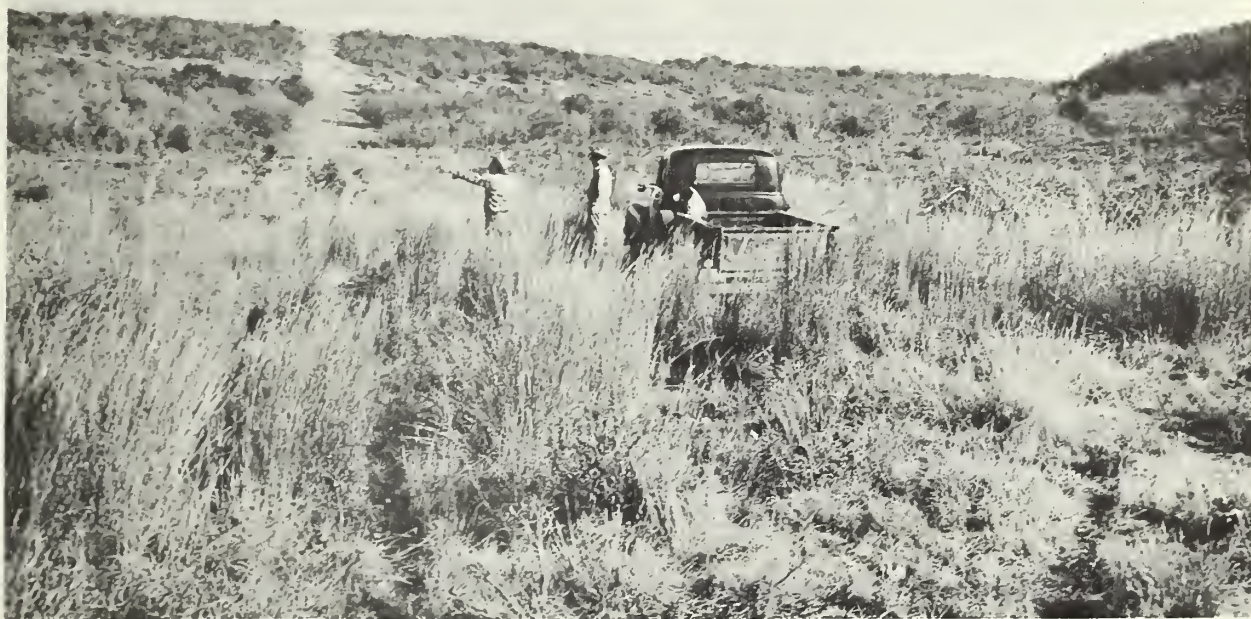
Range-Brush Control. Brush on small tributary and on steep hills left for deer and turkey and for protection against erosion.
